TITLE: The Production of Contamination on  
Spacecraft Surfaces by Hypervelocity Debris  
Impacts

# THE PRODUCTION OF CONTAMINATION ON SPACECRAFT SURFACES BY HYPERVELOCITY DEBRIS IMPACTS

Charles STEIN, Robert ROYBAL and Pawel TLOMAK

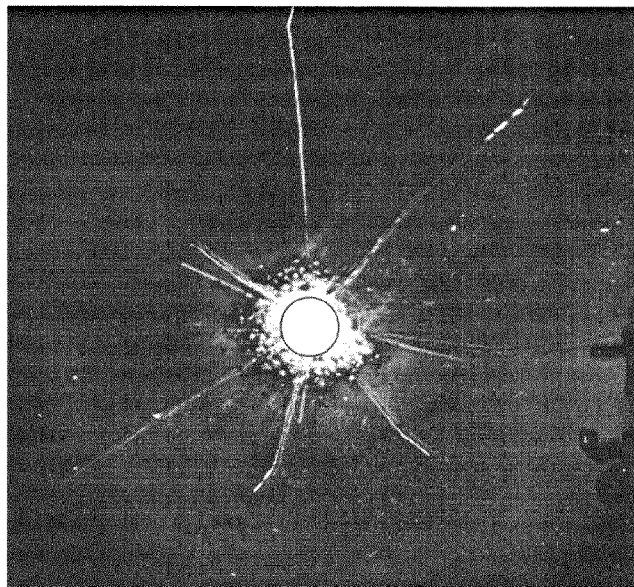
Figure 1 shows a typical optical micrograph image of an impacted coverglass target in which the mechanical damage resulted from an impact at 4 km/s. Radial cracks extend from the impact crater to the edge of the 4 cm sample. The dashed circle in the center of the image represents the size and impact location of the 3 mm flyer. Figure 2 is a typical SEM image of the rear surface of an impacted target and shows that some glass material has been removed from the rear surface. The predominant damage observed on the rear surface of targets was cracking and uplifting of the glass, however the glass remains attached to the laminate, similar to common safety glass.

Fig. 1. 4X Optical image of a coverglass laminate.

When considering the overall efficiency of the solar cell, contamination from the vapor blown out of the impact crater may actually be the most serious consequence of damage to the cover glass. An interesting phenomena is seen when examining the deposition of ejecta from the impact crater onto the target surface. The ejected plasma forms bands of different material densities radiating out from the crater. Fig. 4 is a schematic diagram of the impacted sample shown in Fig.1, where area (A) represents

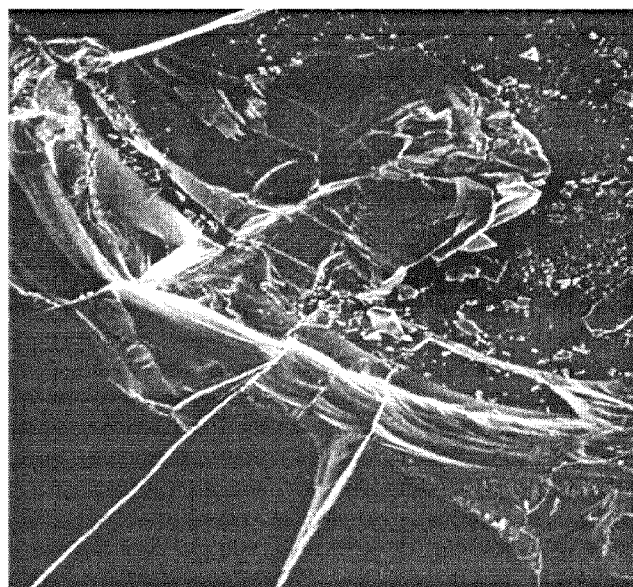
Fig. 2. A 40 X Typical SEM image of rear surface of a coverglass laminate.

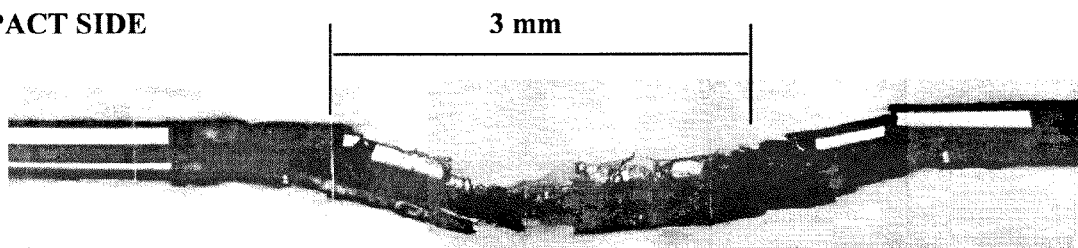
IMPACT SIDE

Figure 3 shows a typical image of the cross-section of an impacted cover glass laminate sample. The impacted side, as well as the surrounding areas, suffered extensive damage to both layers of the glass laminate. The damage included extensive cracking of the glass layers and permanent deformation primarily within the impact area. Upon impact, the aluminum particle formed a crater concave towards the impact

direction. As a result, the glass on the impact side was extensively cracked but still remained attached to the deformed laminate. On the other hand, much of the

cracked glass on the rear side of the impacted cover glass was uplifted and spalled off.

Fig. 3. Optical image of a cross section of an impact site on a coverglass laminate.

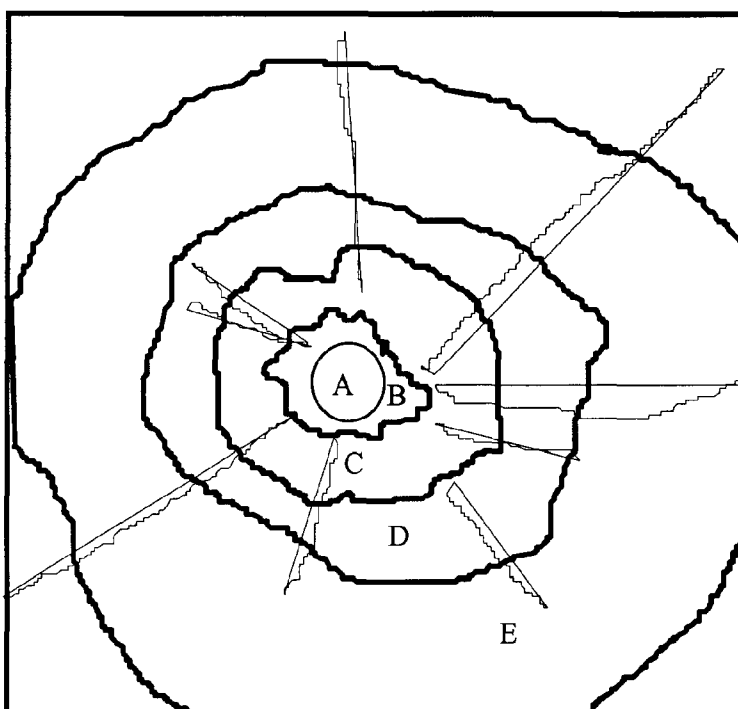
Fig. 4. Schematic of an impact area showing outlines of re-deposition regions.

the size of particle impacting the surface; region (B) is the crater area in which material has been removed from the target; molten aluminum is found in area (C), where aluminum is also found on the entire sample in the form of trace deposited vapor; area (D) remained relatively free of re-deposition; and at a distance of over 1 cm from the impact site, area (E), the surface is heavily coated with the vapor removed from the crater.

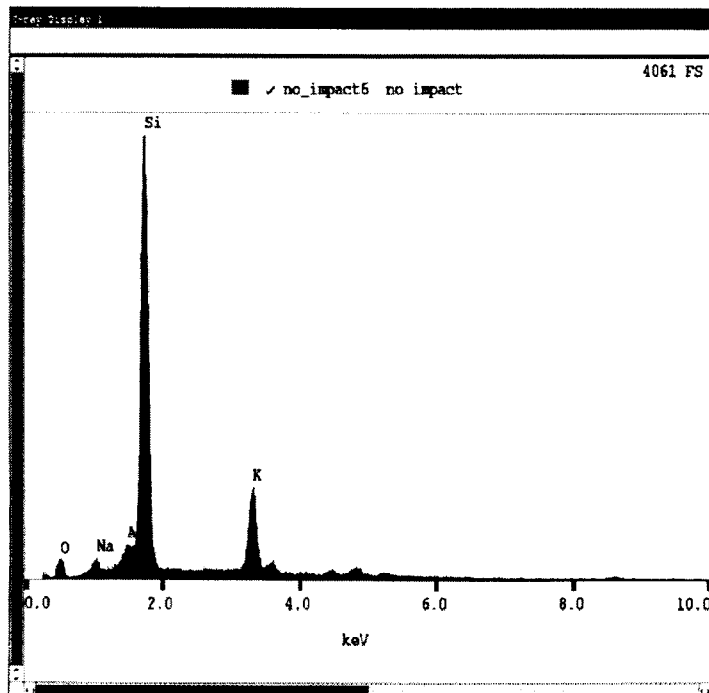
An elemental analysis of the coverglass surface was completed using a PGT energy dispersive system attached to our scanning electron microscope, and produced the qualitative elemental analysis shown in Figures 5, 6 and 7. Figure 5 shows a "control" spectra consisting primarily of silicon and potassium for a coverglass sample that has not been impacted. Figure 6 is an energy dispersive spectra of the impact crater,

Figure5. Energy dispersive spectrum of a non impacted coverglass.

The above spectra show that a deposition of fluorine, carbon, and aluminum are now present in regions of the once clean surface. The fluorine and carbon are generated from the vaporization and ejecta of the Teflon resin layer of the laminate. The probable source

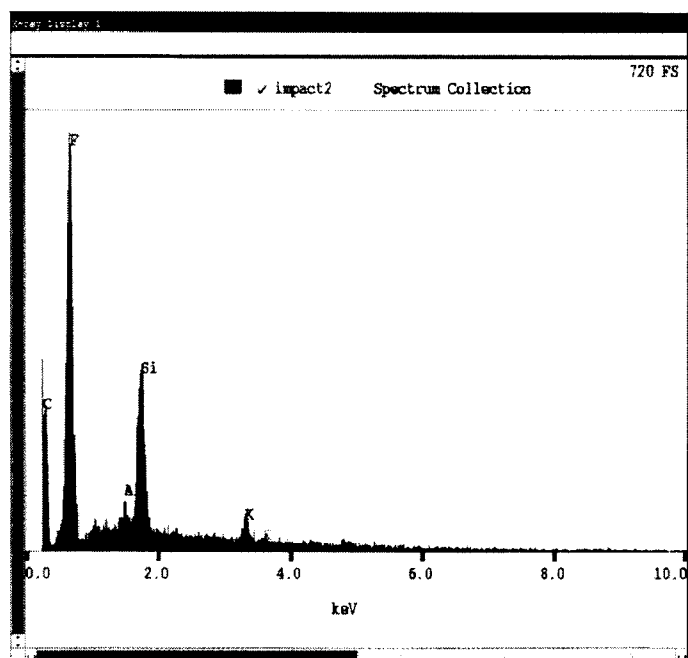
area (A). In the crater area, much of the glass has been removed, revealing the resin layer below which produces the resulting fluorine and carbon lines with reduced intensities of Si and K. The energy dispersive spectra in Figure 7 was collected for area (E) on the coverglass and shows the presence of carbon, fluorine, silicon and aluminum.

Fig. 6. Energy dispersive spectrum of the crater area (A) on an impacted coverglass.

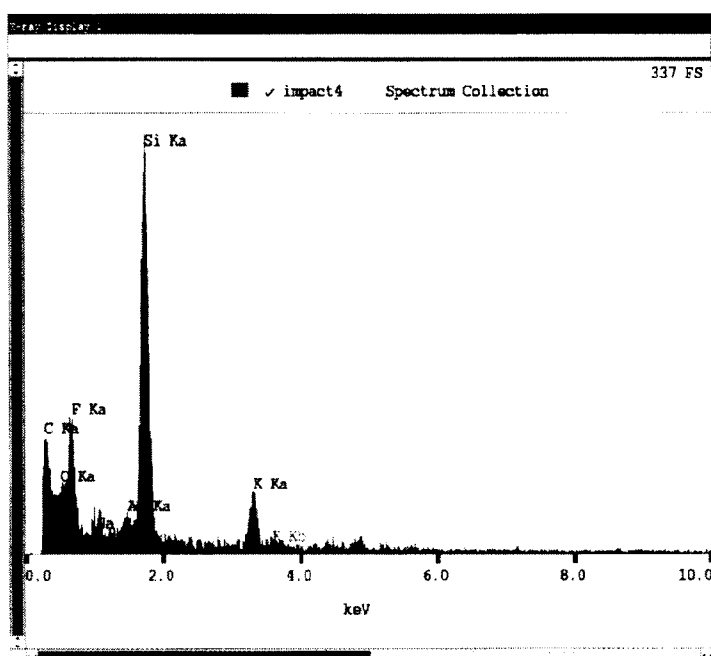
Fig. 7. Energy Dispersive spectrum of area (E) on an impacted coverglass.

of aluminum comes from vaporization of the aluminum flyer.

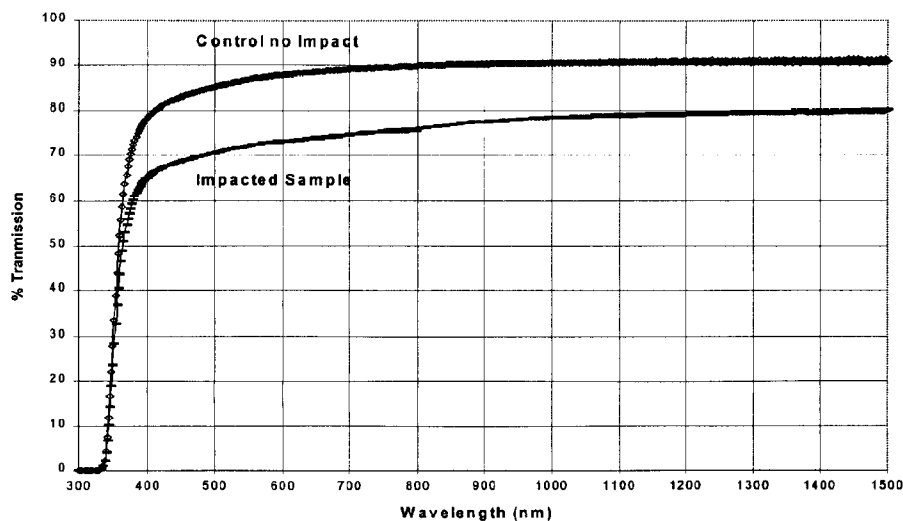
were made using a Cray 5ev Spectrophotometer through impacted targets and control samples. This wave length range covers the useful solar spectra for solar cells. Figure 8 compares transmission spectra of an undamaged control sample to transmission spectra measured in area (E), 1.6 cm from the crater of an

impacted sample. These spectra show that a maximum transmittance of 90 percent exists at the wavelengths of interest in a control sample. However, degradation in the original sample transmittance by approximately 10 - 15% was measured across area (E) of the impacted sample.

Figure 8 Transmission spectra of UV light through a coverglass target pre and post impact.

Light transmission measurements over the wavelengths from 300 nanometers to 1500 nanometers
